WATER and RELATED LAND RESOURCES

EL RIO EN MEDIO SUB-BASIN

UPPER RIO GRANDE BASIN

PRELIMINARY EARLY ACTION OPPORTUNITIES

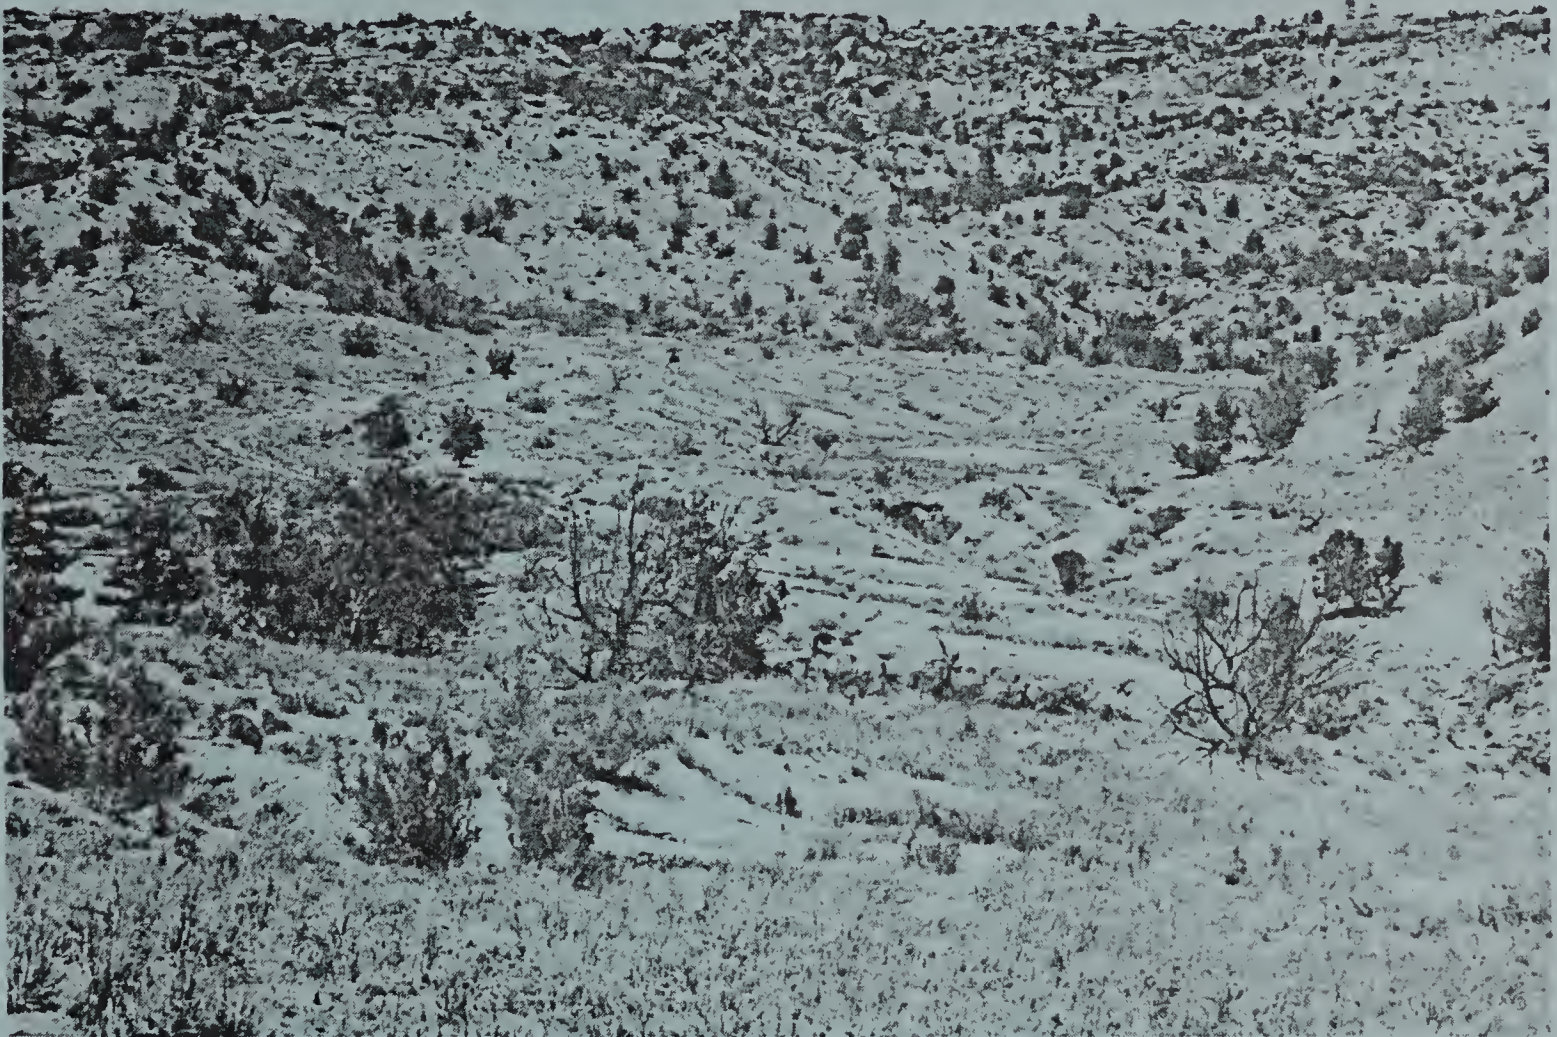
Erosion scars on Acoma Creek Drainage SCS PHOTO 12-P992-9

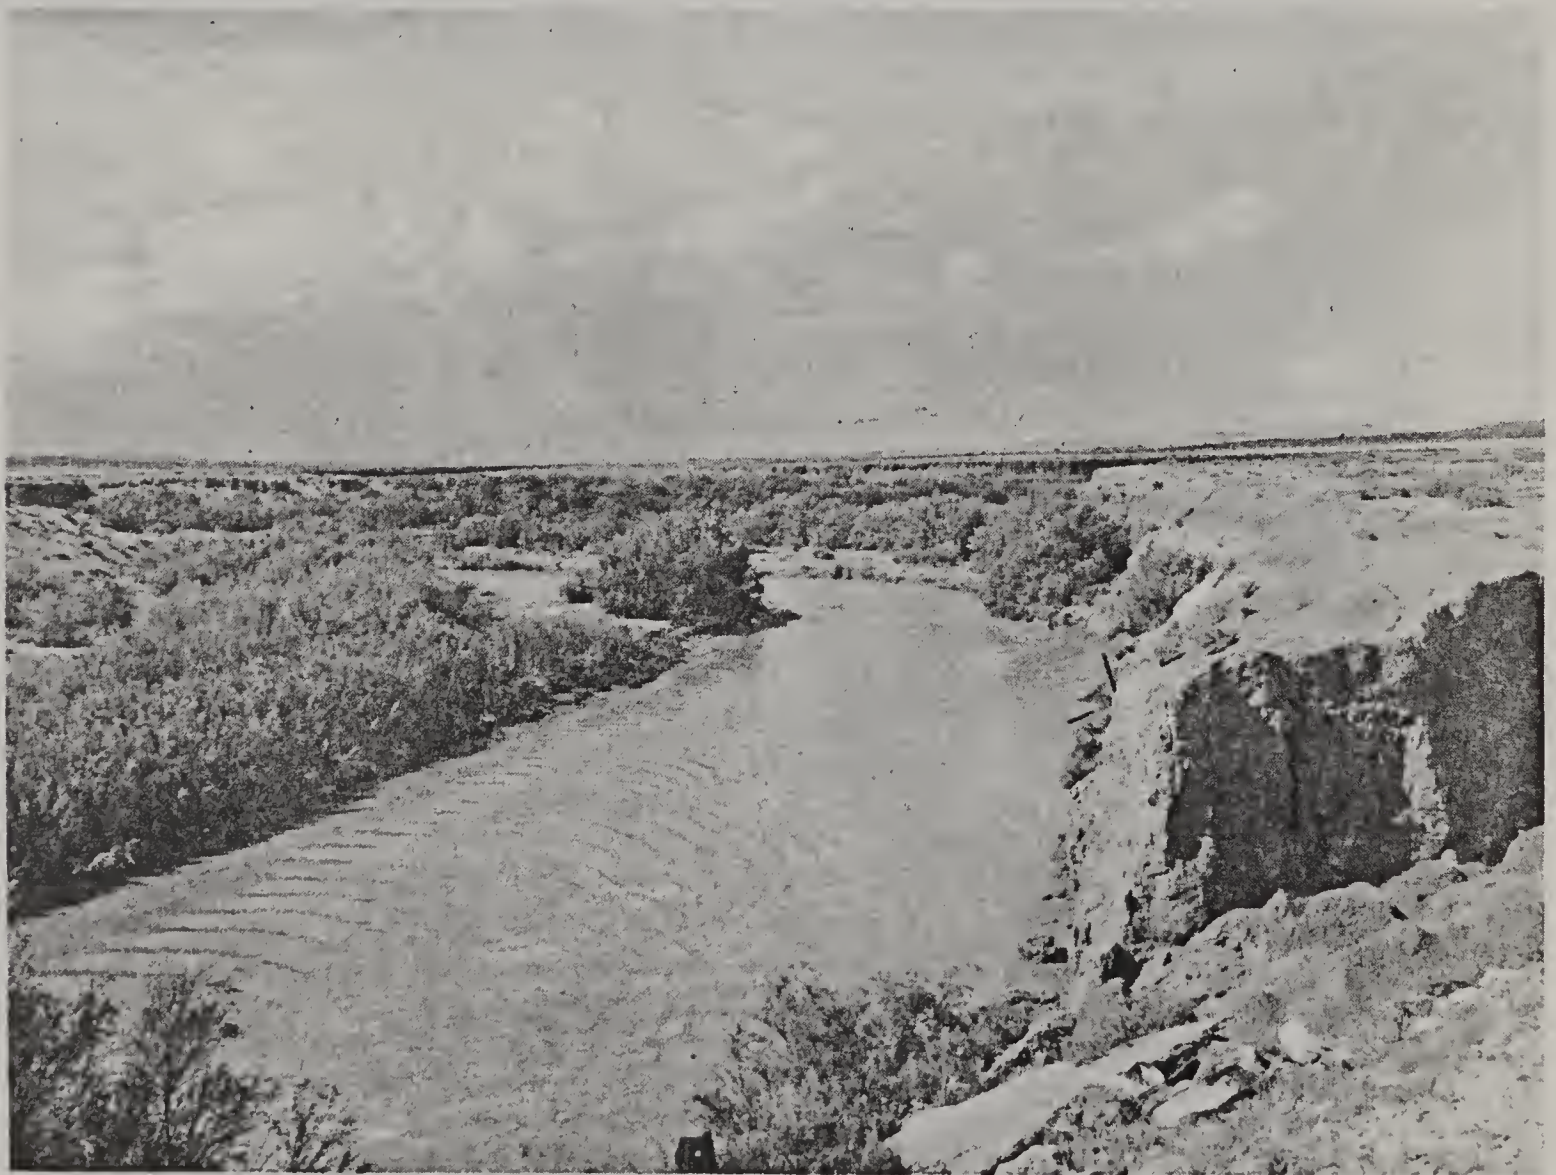
Rio Puerco (Dirty River) carries a heavy sediment load and supports dense areas of phreatophyte vegetation, primarily salt cedar.

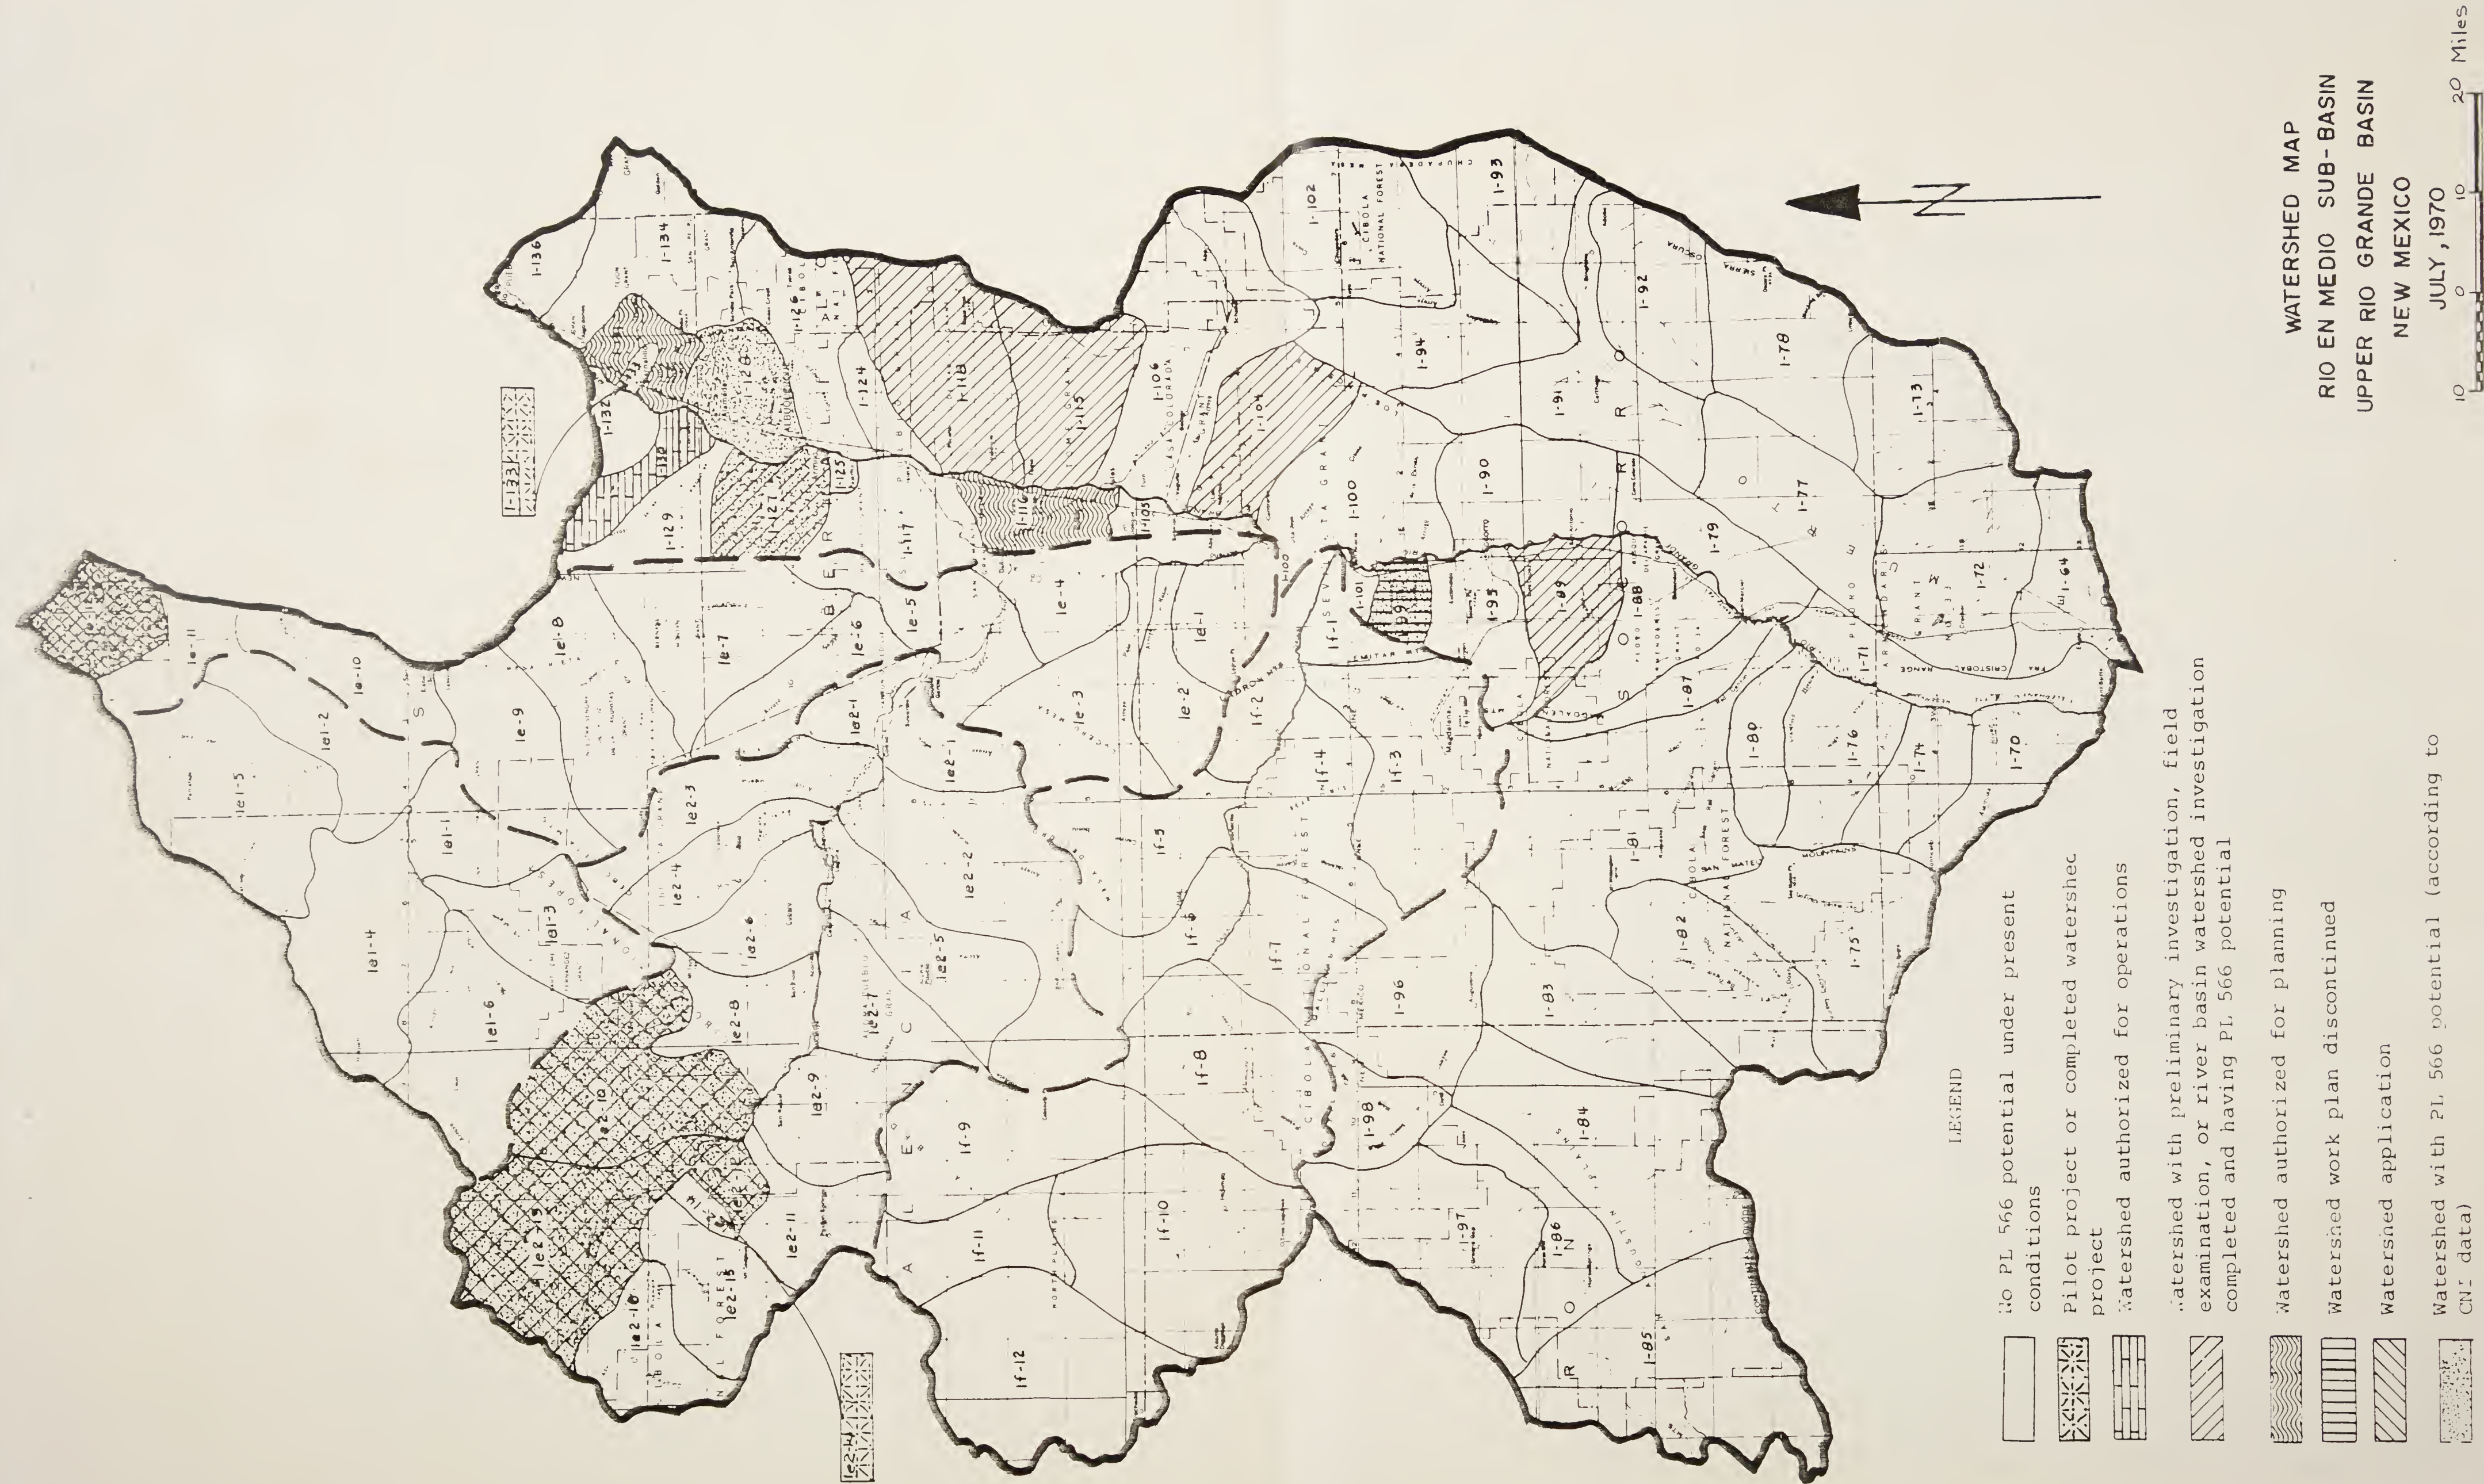
WATERSHED MAP
RIO EN MEDIO SUB-BASIN
UPPER RIO GRANDE BASIN
NEW MEXICO

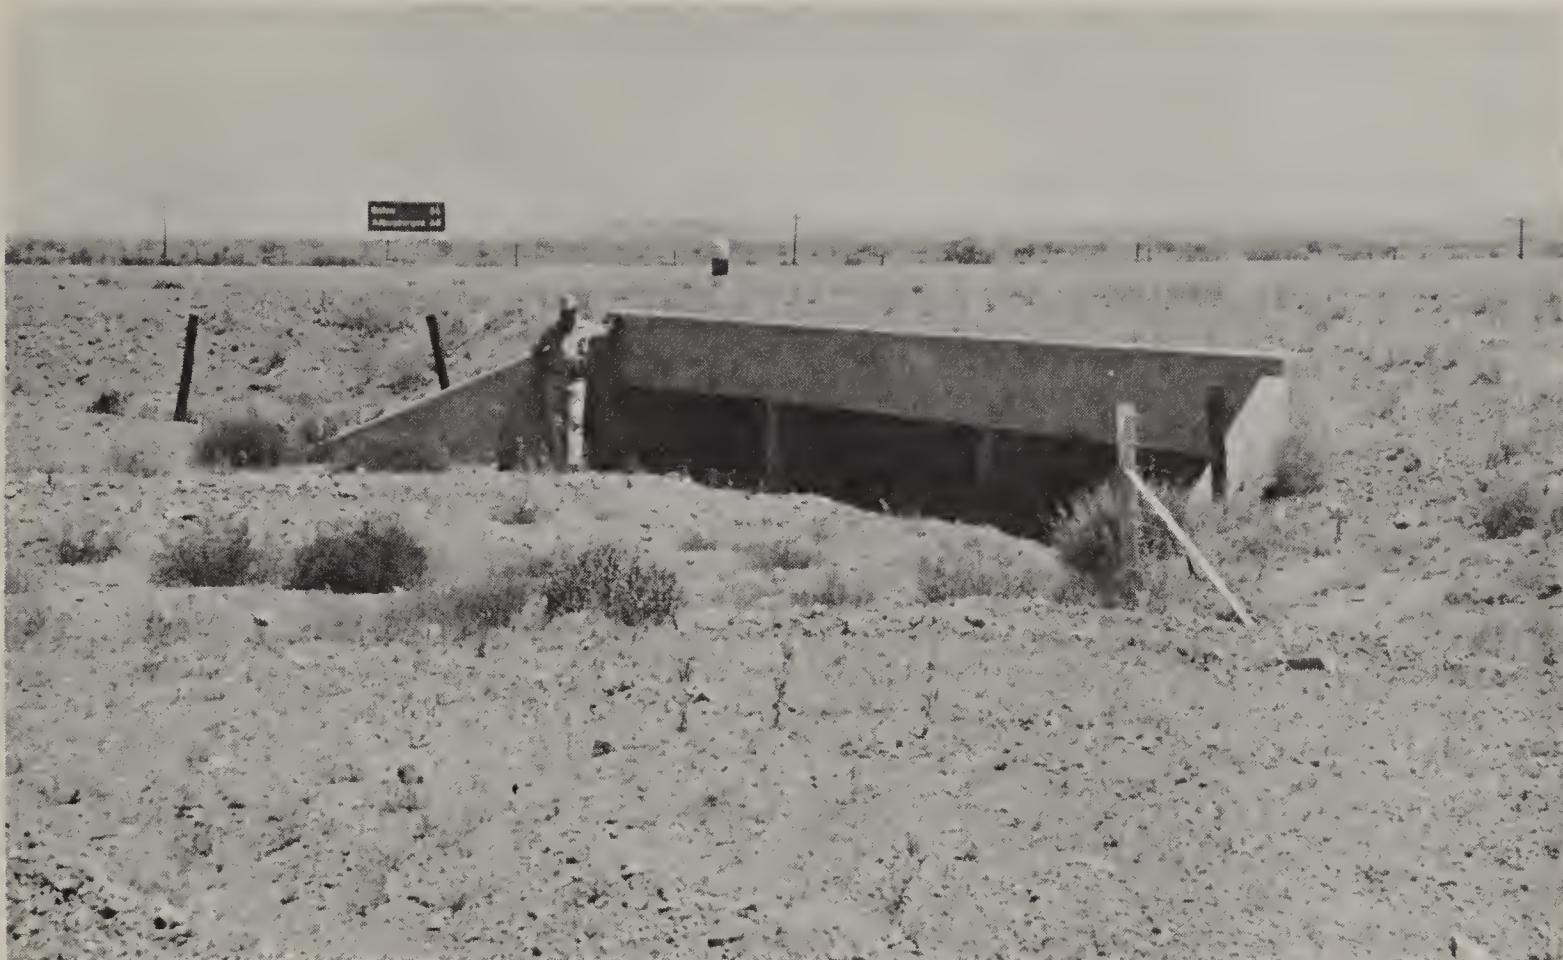
Upstream side of culvert under U. S. Interstate 25 below proposed site 4

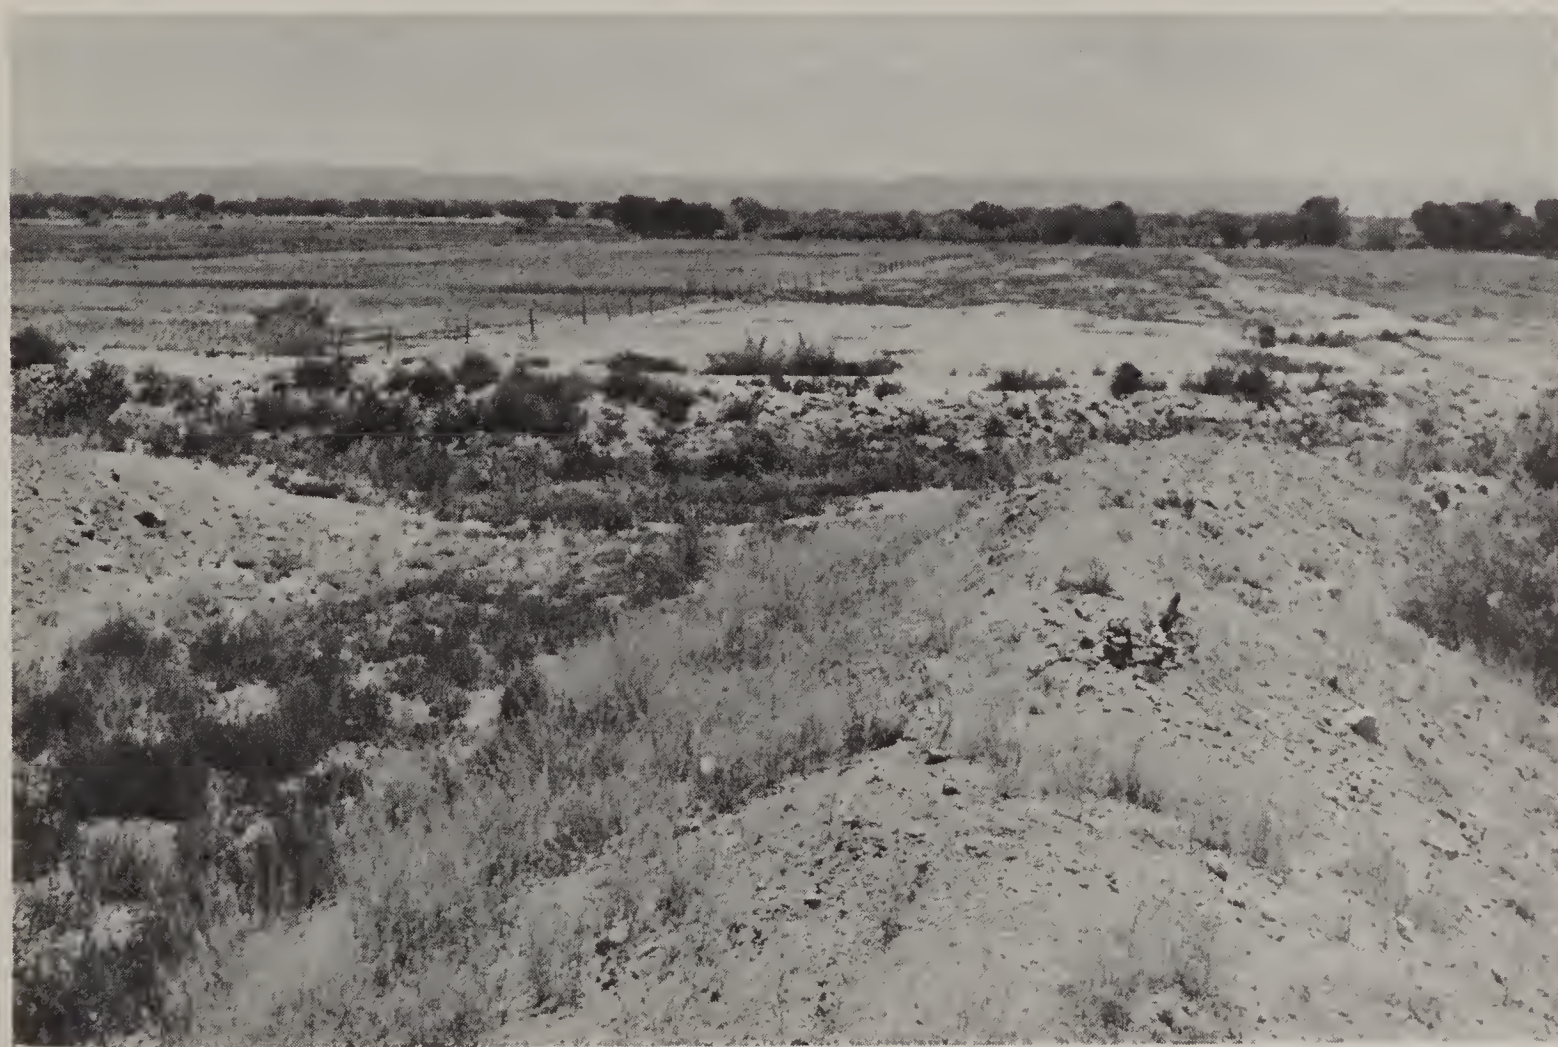
Same arroyo terminating in irrigation canal. Note sediment on fields below canal where canal bank has broken allowing sand and gravel to damage cropland.

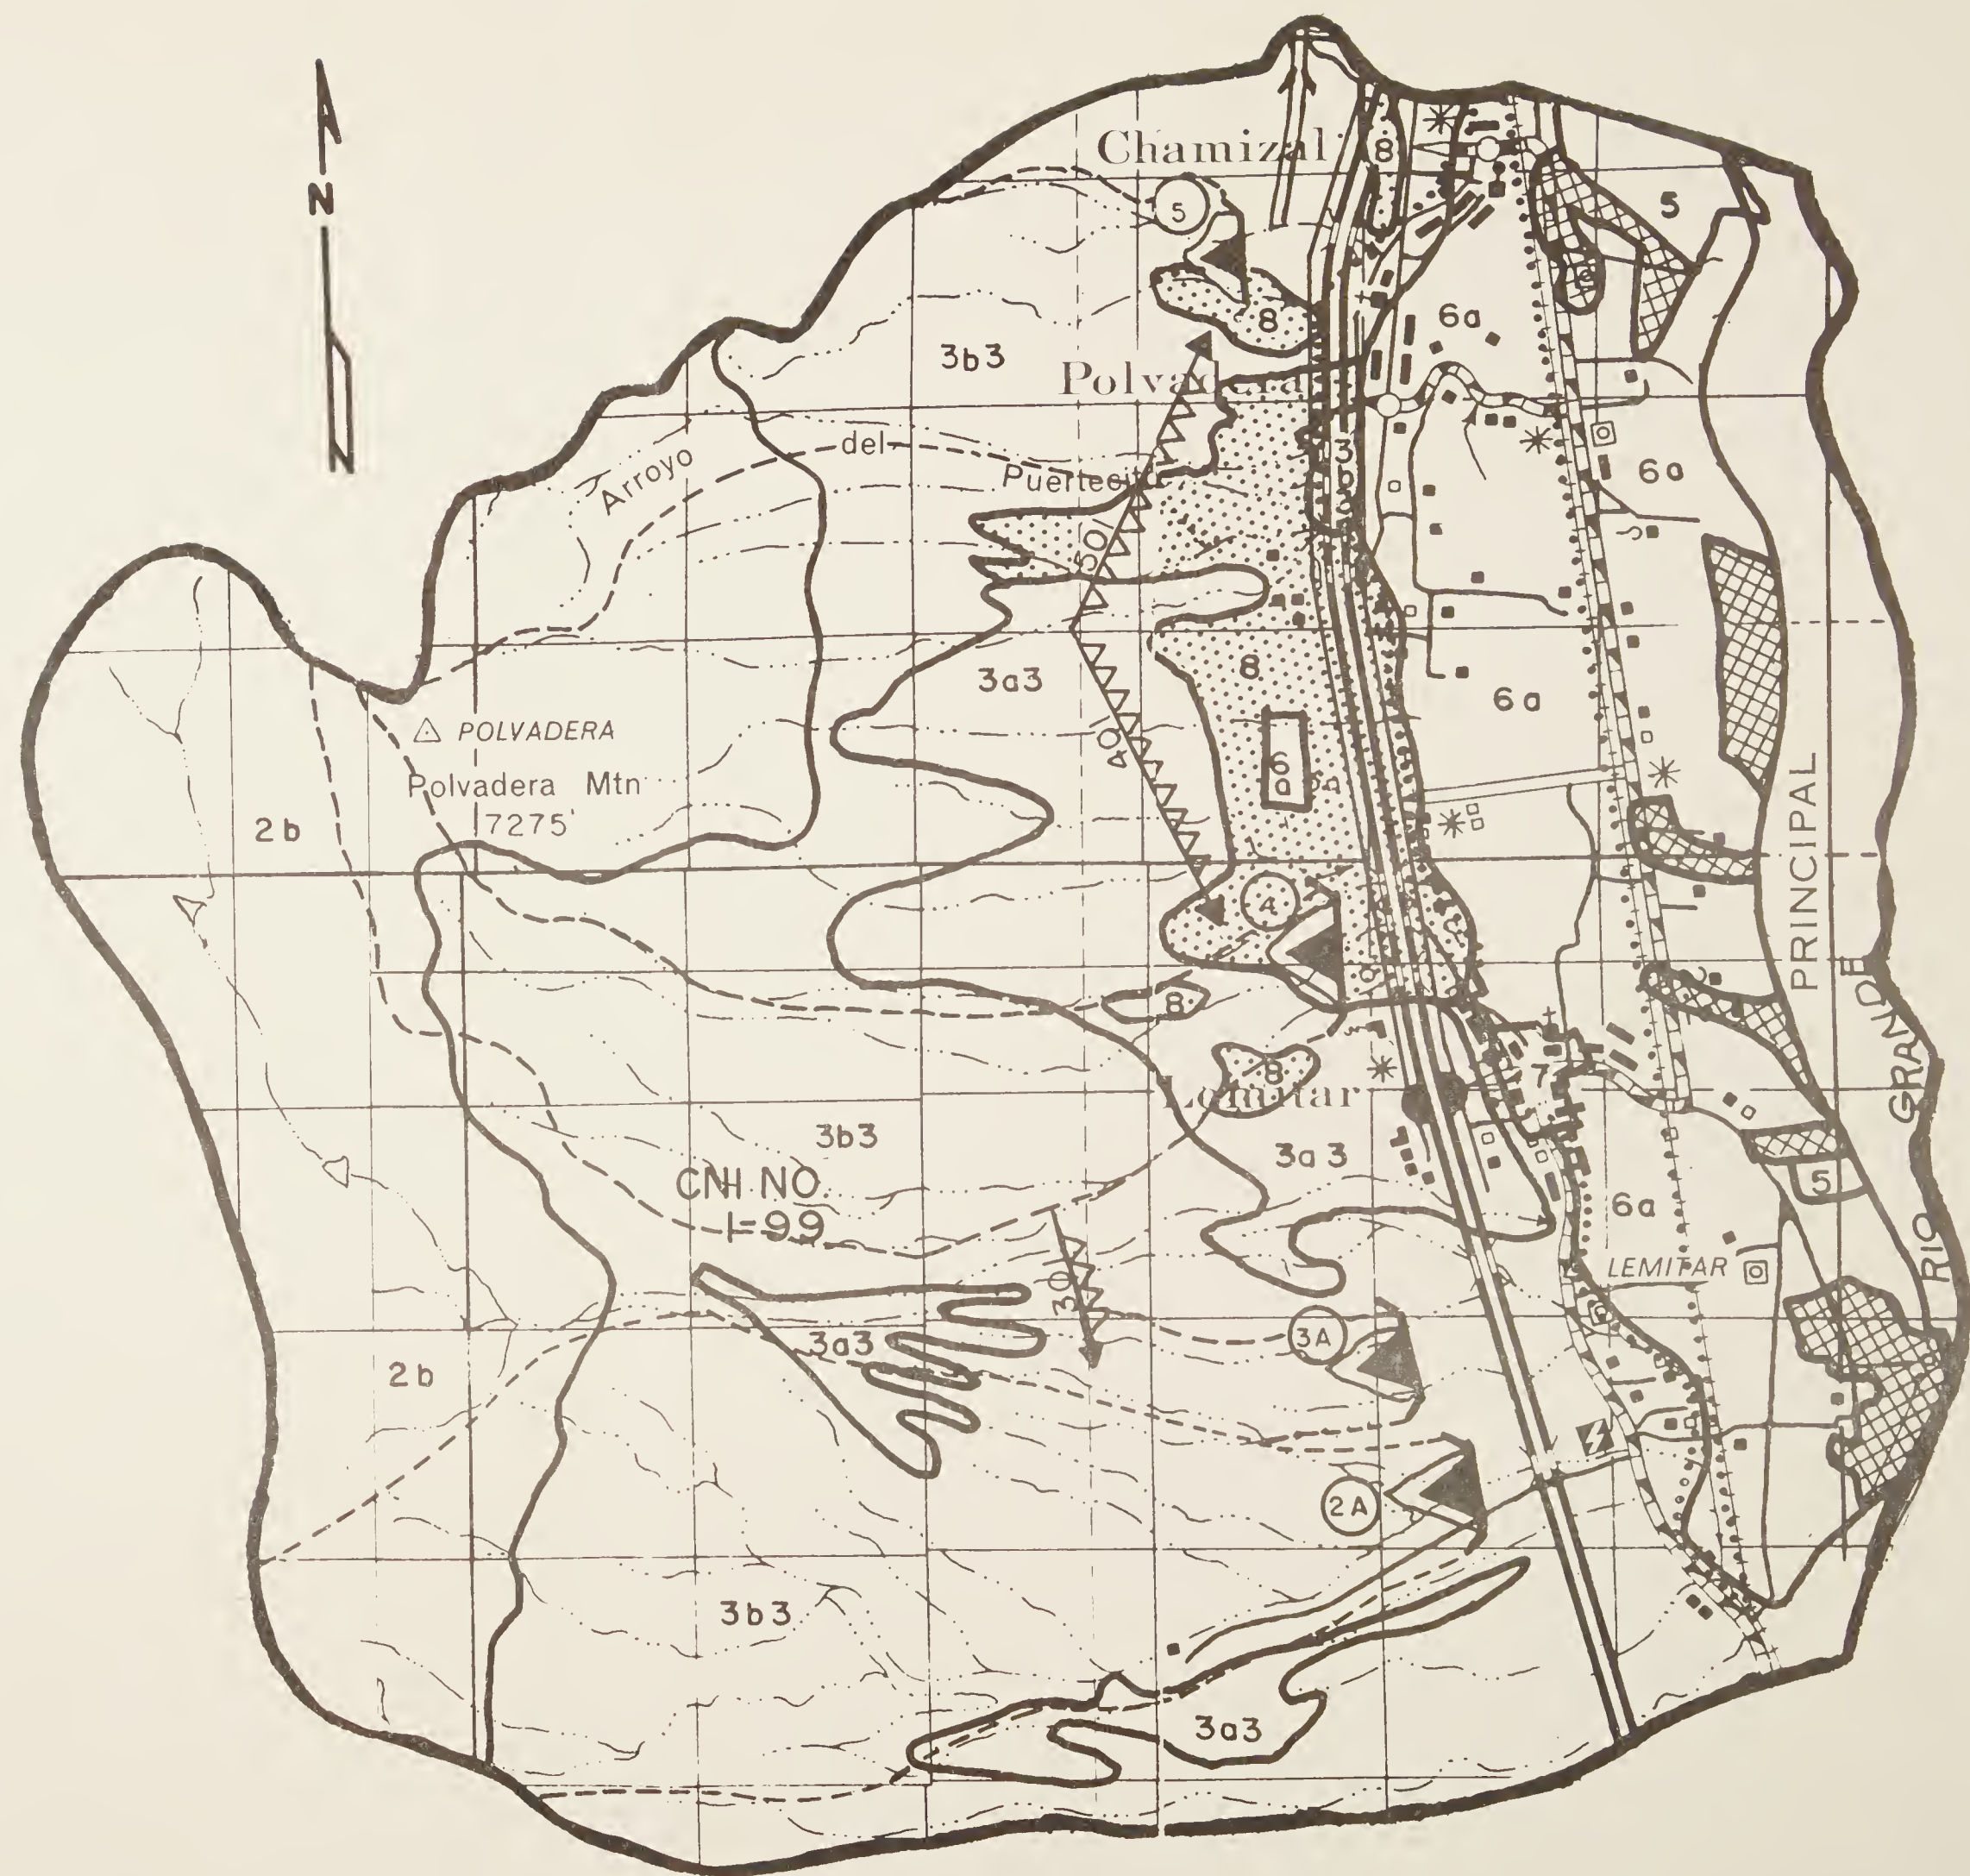
STRUCTURE LOCATION
AND
LAND TREATMENT MAP
LEMITAR-POLVADERA WATERSHED
UPPER RIO GRANDE BASIN

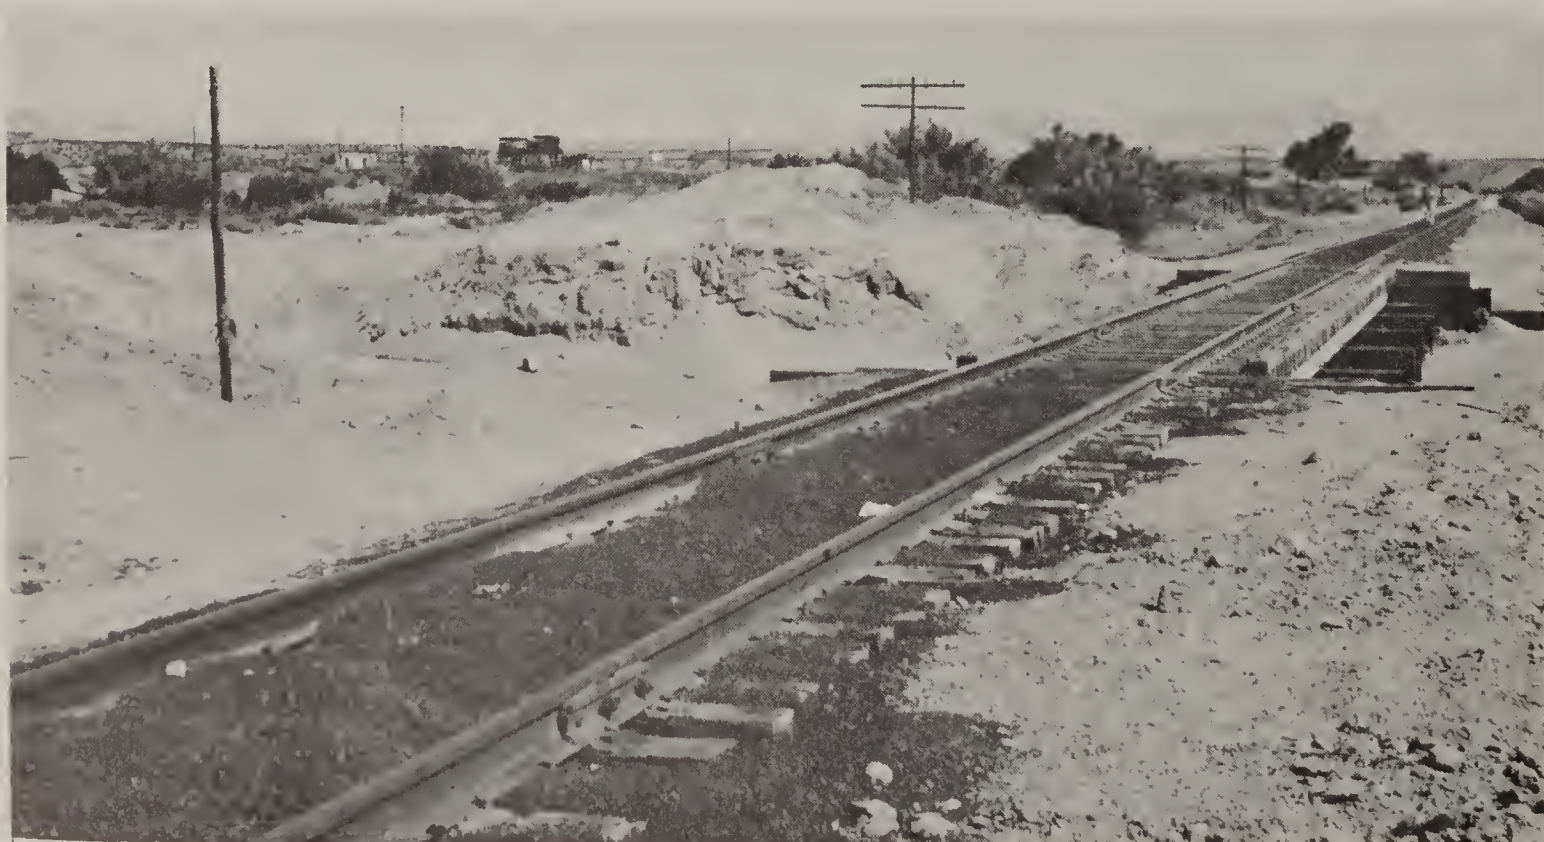
Damage to Santa Fe Railroad right-of-way from Walnut Creek drainage. Track and bridge have been recently raised 18 inches to allow more clearance under the trestle

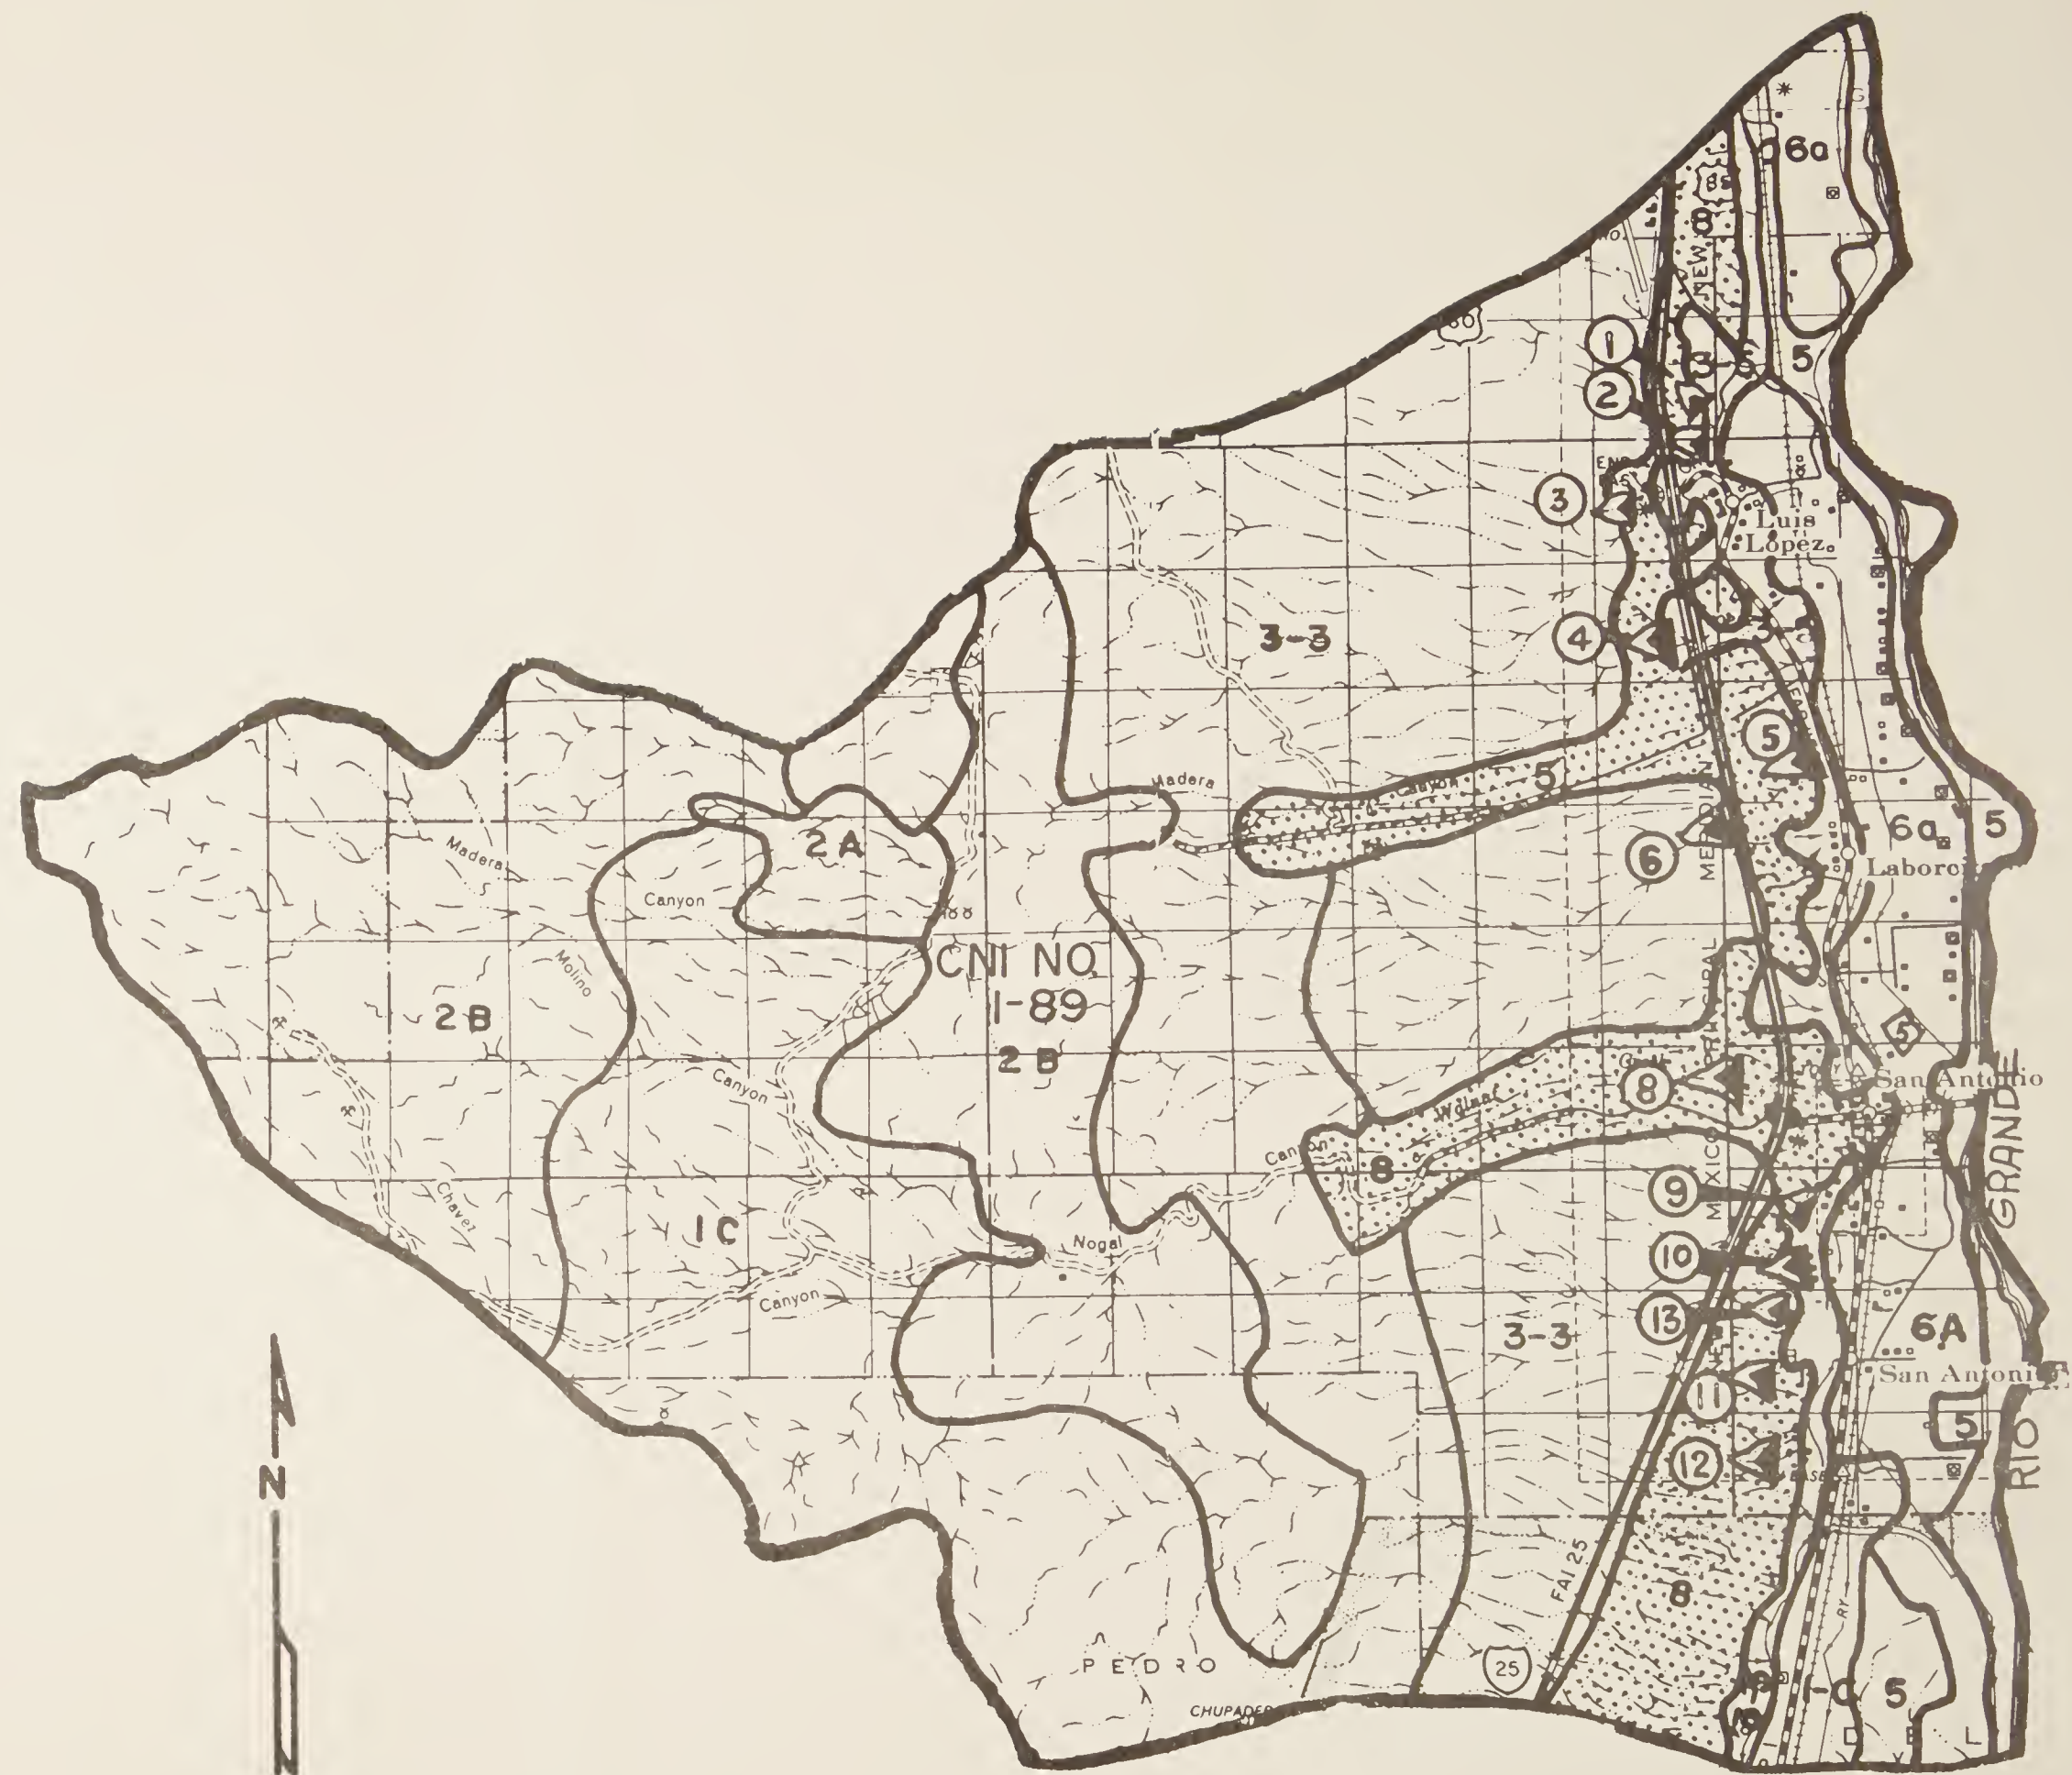
STRUCTURE LOCATION
AND
LAND TREATMENT MAP
WALNUT CREEK WATERSHED
UPPER RIO GRANDE BASIN

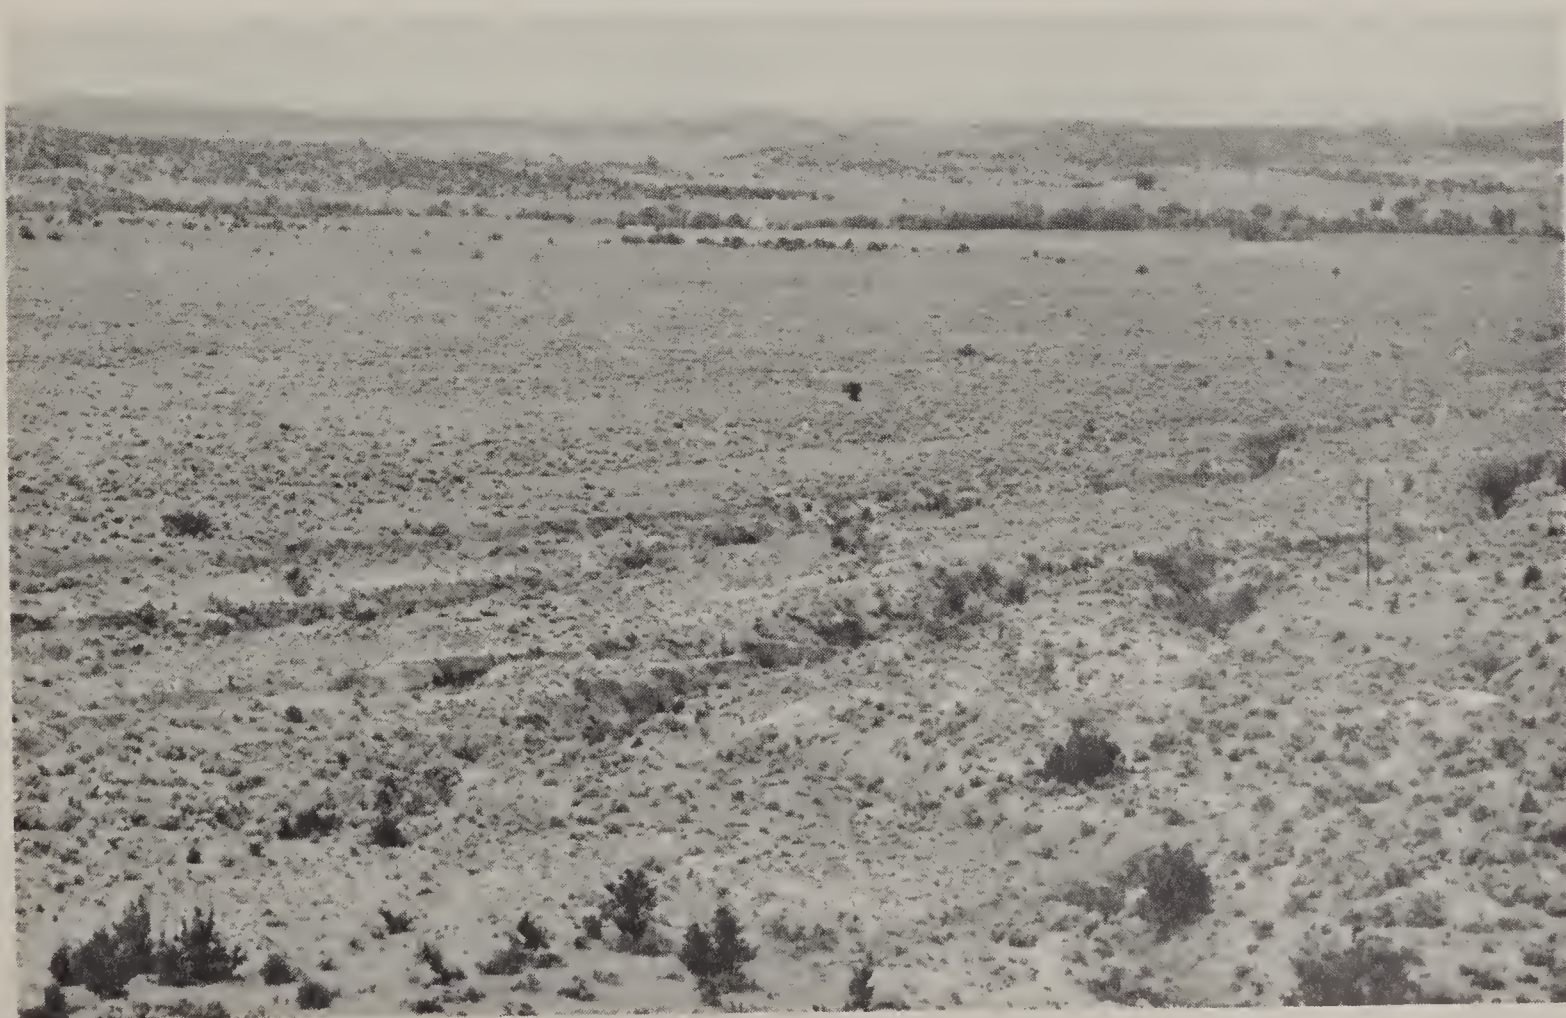
Deep gullies in shale alluvium on Rito Leche Watershed
